Waste to Energy Plants Suffer from Unplanned Shutdowns Caused by Boiler Failure

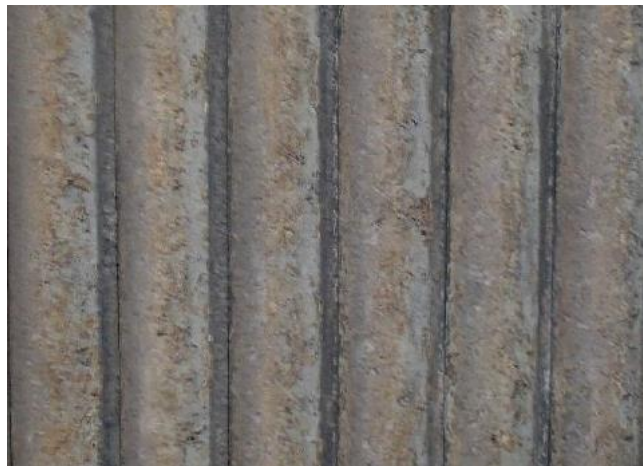
Corroding boiler tubes, Drax, 2018

Often, over time and during continued operation, accelerated corrosion is then observed on the unprotected tubes beyond the WMO section, for example in the second pass (this is commonly referred to as 'corrosion creep'). In this case the scope of tube area protected by a corrosion barrier needs to be extended.

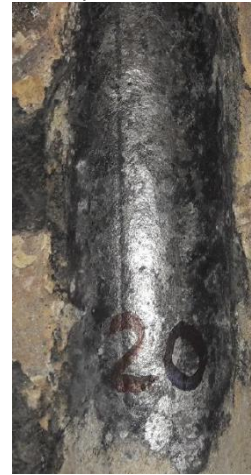
Ageing Weld Overlay, Renergia, 2017

In other cases, in certain parts of the boiler the applied WMO can start to show signs of accelerated wastage due to corrosion after only one or two years in service. This original investment needs to be protected from further rapid degradation which risks the integrity of the underlying water wall.

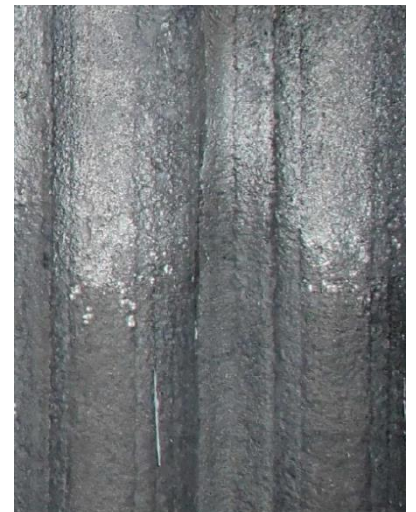
Top half: unprotected Alloy 625 weld overlay section showing wear and degradation.

Bottom half: Area protected with IGS HVTS

interface showed that the area clad with IGS HVTS was no longer affected by corrosion. Unprotected Alloy 625 WMO and other vendor's TS, on the other hand, both continued to degrade.

It was decided that the scope would be extended and that HVTS alloy cladding would be applied to a further 20m² area in 2019. An inspection later that year, in August 2019, confirmed the following. The areas protected with high-velocity thermal spray (HVTS) alloy cladding were not exhibiting any pitting corrosion or wastage. Adjacent unprotected Alloy 625 weld overlay sections were showing signs of wear and degradation.
